# Asbestos cement slates are subject to laws and regulations

Revisions to the Air Pollution Control Act strengthen measures to prevent the release of airborne asbestos fibers.

Asbestos cement slates (level 3) are also subject to laws and regulations.

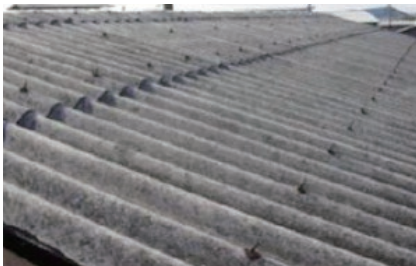
Asbestos-containing slate (wave slate)

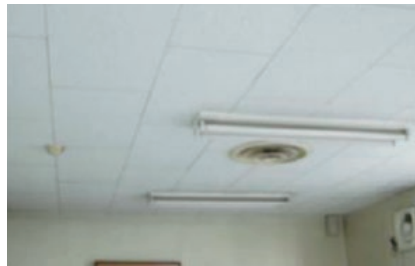
Asbestos-containing ceiling tiles (ceiling)

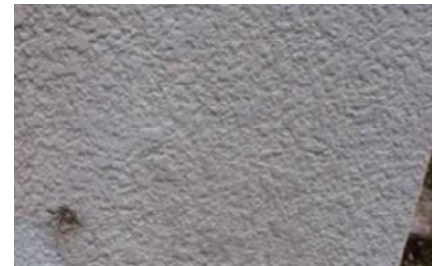
Asbestos-containing texture coating (stucco exterior wall)
